WORKSHOP: HYDROGENATION PROCESS

Process Safety and Risk Management

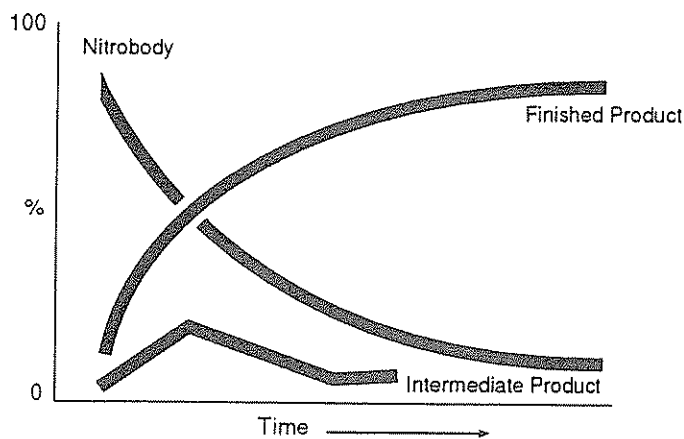
Process B at 110°C

An incident occurred because the process was incorrectly switched from A (previous batch) to B (this charge). The autoclave was charged with B ingredients and the process was run erroneously, using A instructions. Reaction temperatures were 10°C lower than specified for process B. When the error was realized, the temperature was increased by 10°C. An uncontrollable pressure increase occurred shortly after the correction was completed.

The autoclave overpressured because the relief system was inadequate, causing the head bolts to stretch. This pressure drove the autoclave through the floor. No serious injuries resulted, but the property damage was \$1.7 million.

The PSI package was missing the answer to this question: “What happens if process B is run at a temperature lower than normal?” The PSI package should have included:

- Process chemistry
 - Kinetic data on dechlorination reaction
 - Kinetic data on intermediate and side reactions
 - Heats of reaction
- Limits of each parameter
 - Temperature (maximum, minimum, and normal)
 - Pressure (maximum, minimum, and normal)
- Consequences of deviation above maximum and below minimum for *each* parameter

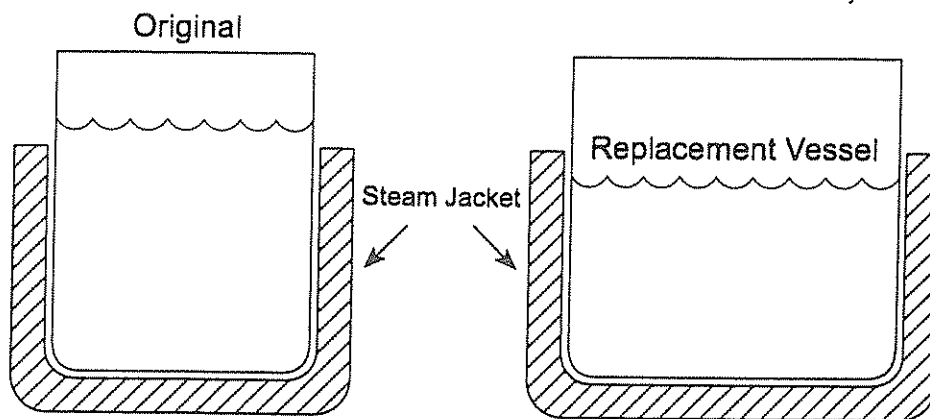
The replacement vessel was a 1,000-gallon, glass-lined vessel, but it was not a replacement-in-kind.

The PSI package requires the liquid level to remain above the vessel's exposed heating surface. If this requirement is not met, the product may dry out and ignite if exposed to air.

A test authorization and PHA were in order in this situation. The test authorization and the PHA are the appropriate mechanisms to document that replacement is indeed identical.

A comparison of all the specifications for the two vessels would have shown that the two vessels did not have identical L/D dimensions and that nozzle orientation was different. It must also be ascertained that the two vessels are correctly defined in their respective documentation. Many differences come to the surface when supposedly identical replacements are compared, using the following question raised in a PHA: "What are the differences in the two equipment pieces?" Note: A PHA based on P&IDs only would not have revealed the above critical differences.

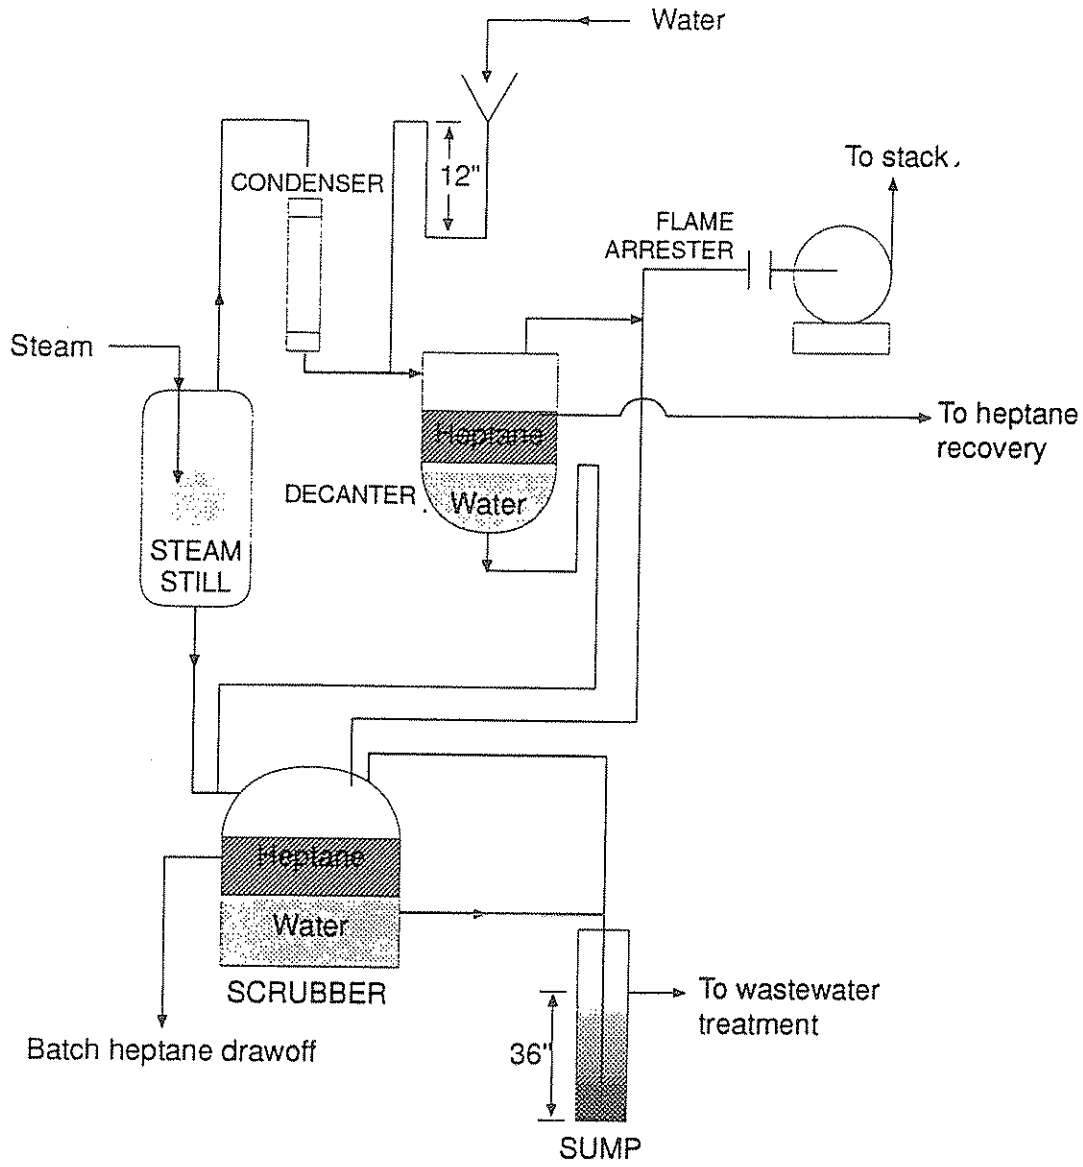
HEPTANE RECOVERY

The seal leg was increased from 12 inches to 72 inches. Two hours later, an explosion and fire occurred in the covered waste stream between the scrubber and the wastewater treatment facility.

1. The flash screen, installed in the vent six months earlier (a PHR recommendation), became restricted.
2. The resulting increase in pressure caused heptane to vent through the 12-inch seal leg on the decanter.
3. The seal leg was increased to 72 inches.
4. Next, the system began to vent through the path of least resistance—the 36-inch seal leg at the base of the scrubber. Heptane vapors entered the covered aqueous waste stream ditch, forming a flammable gas mixture.
5. Sparks from a welder's torch downstream ignited the vapors.

1. The flash screen should have been placed on an inspection schedule. Frequent initial inspections are necessary to determine susceptibility to pluggage.
2. The system should have been shut down until the cause of heptane venting was understood.
3. Modifications to the system should not have been made until reviewed via a PHA and a TA.
4. The operations supervisor and his superior had been recently assigned to the area and did not possess adequate knowledge of the process or of PSRM. Management at some level should have recognized the need for additional checks and balances because of so much supervisory inexperience. At a minimum, temporary backup from either higher supervision in the production organization or from technical supervision should have been provided for such process decisions.
